Army Lodging Wellness Recommendation

Fort Bliss - Final Submittal

August 14, 2003

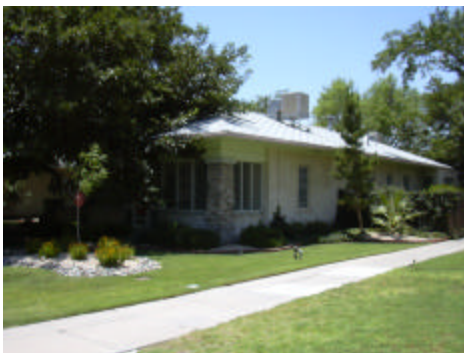
Building 213

Building 213, constructed in 1914, houses 1 DVQ suite. This facility is in fair condition but does not meet Lodging standards and cannot be reconfigured without significant reconstruction. The cost to make improvements and to bring this facility up to Army Lodging standards will exceed the 50% replacement cost.

Our recommendation is to remove building 213 from the Lodging inventory, allowing the installation to determine an alternate use for this facility. This facility will be removed from the Fort Bliss Wellness Solution and Lodging Master Plan.

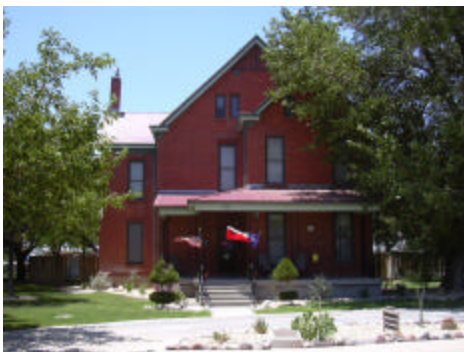
Building 220

Building 220, constructed in 1893, houses 1 DVQ suite. This facility is in fair condition but does not meet Lodging standards and cannot be reconfigured without significant reconstruction. The cost to make improvements and to bring this facility up to Army Lodging standards will exceed the 50% replacement cost.

Our recommendation is to remove building 220 from the Lodging inventory, allowing the installation to determine an alternate use for this facility. This facility will be removed from the Fort Bliss Wellness Solution and Lodging Master Plan.

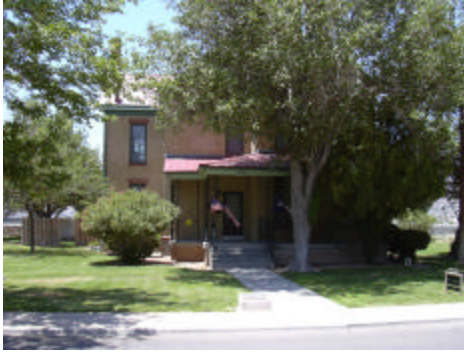
Building 223

Building 223, constructed in 1893, houses 1 DVQ suite. This facility is in fair condition but does not meet Lodging standards and cannot be reconfigured without significant reconstruction. The cost to make improvements and to bring this facility up to Army Lodging standards will exceed the 50% replacement cost.

Our recommendation is to remove building 223 from the Lodging inventory, allowing the installation to determine an alternate use for this facility. This facility will be removed from the Fort Bliss Wellness Solution and Lodging Master Plan.

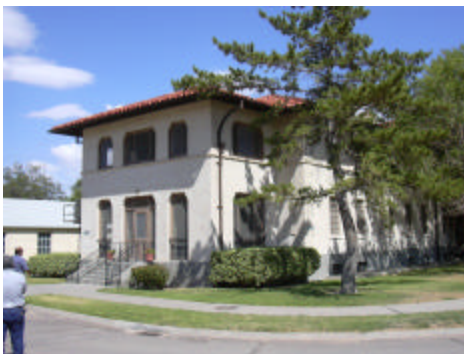
Building 243

Building 243, constructed in 1939, is an historical structure housing 20 extended stay rooms. This facility is in fair condition but does not meet Lodging standards and cannot be reconfigured without significant reconstruction. The cost to make improvements and to bring this facility up to Army Lodging standards will exceed the 50% replacement cost.

Our recommendation is to remove building 243 from the Lodging inventory, allowing the installation to determine an alternate use for this facility. This facility will be removed from the Fort Bliss Wellness Solution and Lodging Master Plan.

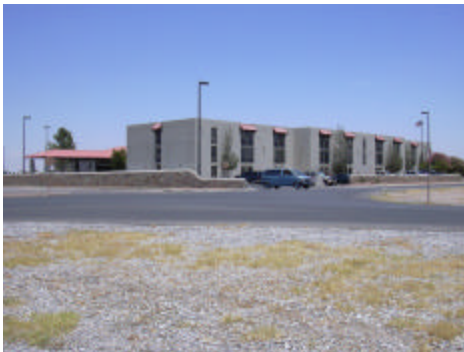
Building 1744

Building 1744, initially constructed in 1989, received a major addition in 1997. This building has 151 standard stay rooms and 3 family suites, and is the main Lodging facility on the post. The building is in good condition, but several support spaces are not included and are required by current Army Lodging standards. The cost to make improvements and to bring up to Army Lodging standards will not exceed the 50% replacement cost.

Our recommendation is to retain building 1744 in the Lodging inventory, and to renovate support spaces to meet current standards. This facility will continue to serve as the main Lodging facility in the Fort Bliss Wellness Solution and Lodging Master Plan.

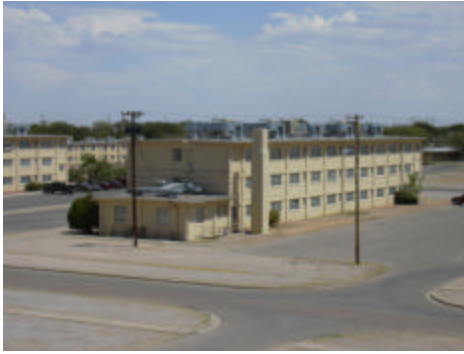
Buildings 5015, 5016, 5017, 5018, 5020, & 5023

These buildings, constructed in 1956, are 3-story structures. Buildings 5017, 5018, & 5023 each contain 27 family suites. Building 5015 consists of 26 family suites. Building 5016 consists of 18 family suites, with its bottom floor containing administrative offices. Building 5020 consists of 28 suites. Although these buildings have similar floor plans, several rooms in each building have been diverted to different functions. These buildings are in poor condition nearing the end of their useful lives and do not meet functional requirements. The cost to made condition assessment improvements will exceed the 50% replacement cost.

Our recommendation is to remove these buildings from the Lodging inventory, allowing the installation to determine alternate uses for these facilities. These facilities will be removed from the Fort Bliss Wellness Solution and Lodging Master Plan.

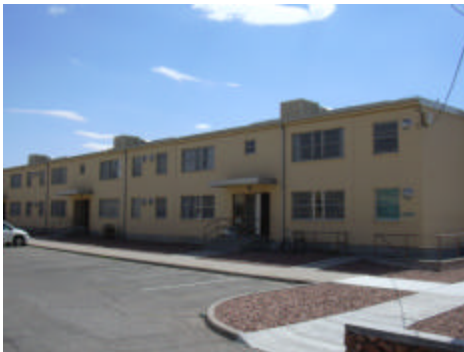
Buildings 5039 & 5040

Buildings 5039 and 5040, constructed in 1958, each consists of 11 two-bedroom suites. The buildings are in poor condition with the building systems nearing the end of their useful lives, and the suites exceed Army Lodging square footage requirements. The cost to make condition assessment improvements will exceed the 50% replacement cost.

Our recommendation is to remove buildings 5039 and 5040 from the Lodging inventory, allowing the installation to determine alternate uses for these facilities. These facilities will be removed from the Fort Bliss Wellness Solution and Lodging Master Plan.

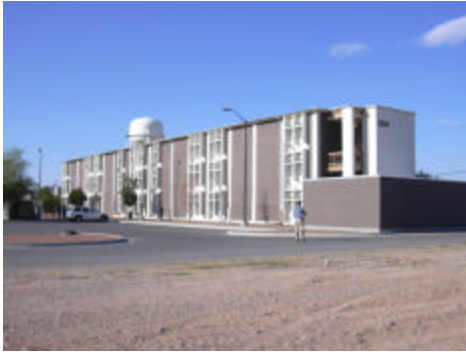
Building 11332

Building 11332, constructed in 1958, received a major renovation in 1994 and currently houses 40 extended stay rooms. This building is located at Biggs Army Airfield and is typically used to house students attending the Sergeants Major Academy. These facilities are in good condition, although the rooms exceed Army Lodging size requirements and some of the support spaces do not meet requirements. The cost to make improvements and to bring up to Army Lodging standards will not exceed the 50% replacement cost.

Our recommendation is to retain building 11332 in its current configuration as a part of the Lodging inventory. This facility will continue to serve as part of the Fort Bliss Wellness Solution and Lodging Master Plan.

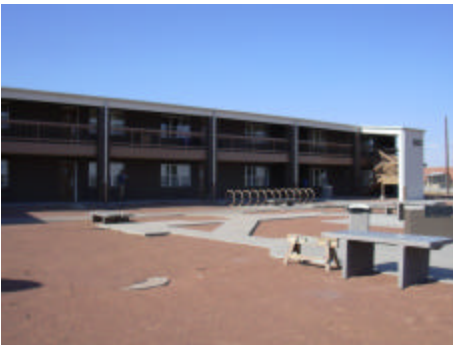
Building 11340

Building 11340, constructed in 1959, received a major renovation in 1995 and currently houses 29 extended stay rooms. This building is located at Biggs Army Airfield and is typically used to house students attending the Sergeants Major Academy. These facilities are in good condition, although many of the rooms exceed Army Lodging size requirements and some of the support spaces do not meet requirements. The cost to make improvements and to bring up to Army Lodging standards will not exceed the 50% replacement cost.

Our recommendation is to retain building 11340 in its current configuration as a part of the Lodging inventory. This facility will continue to serve as part of the Fort Bliss Wellness Solution and Lodging Master Plan.

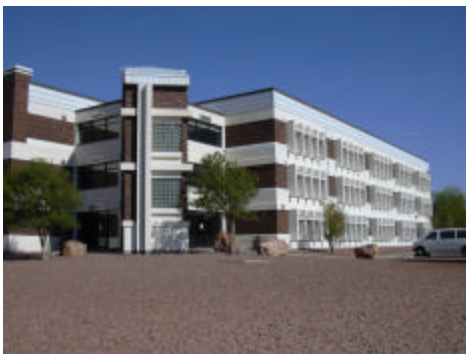
Building 11345

Building 11345, constructed in 1994, consists of 94 extended stay rooms. The building has 100 rooms with some rooms being diverted to support spaces. These rooms are relatively close to current Army Lodging size requirement, at approximately 275 square feet each. This building is located at Biggs Army Airfield and is typically used to house students attending the Sergeants Major Academy. Some of the support spaces do not meet requirements. This building is in excellent condition and condition assessment and renovation improvements will not exceed the 50% replacement cost.

Our recommendation is to retain building 11345 as a part of the Lodging inventory. This facility will continue to serve as part of the Fort Bliss Wellness Solution and Lodging Master Plan.

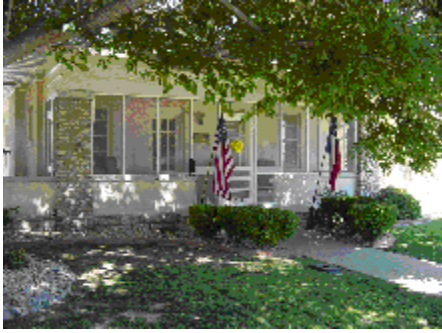
Building 00213

Building 213 was constructed in 1914. The 2,451 square foot facility contains a single DVQ with a full kitchen. The building is functioning as a family suite for high ranking visitors.

Because the Renovation to Replacement Cost Ratio is greater than 50%, renovation of Building 213 is not recommended.

- Analysis: The foundation is constructed of stone walls and footers. Interior foundation walls and brick piers support the interior structure. No clear failures can be seen from perimeter. The foundation is in good condition.
- Recommendation: No corrective action is required.
